CAPITAL RESERVE STUDY

**LONGVIEW AT MONTVILLE
ASSOCIATION, INC.
MONTVILLE, N.J.**

**May 2012
Project Number: 2727.0001**

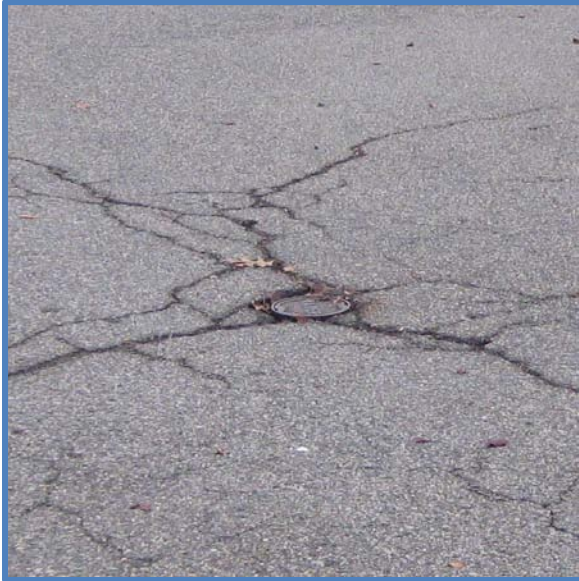
Pavement Failure at Water Valve

The existing surfaces of the roadways were observed to be in average to below average condition containing longitudinal and transverse cracking, some areas of alligating, separation at installation seams, pavement failure at utilities, depressed areas, patches indicating areas of previous repairs and edge failure, particularly at storm inlets. Regular maintenance of the asphalt surface including crack filling and localized pavement repair will extend the useful life of the pavement system.

Prior to the installation of a new wearing course, reconstruction of areas containing base course failure, crack repair, milling along existing curbs and around utility penetrations is required. The costs to perform these additional operations are included in the unit cost provided within the schedule.

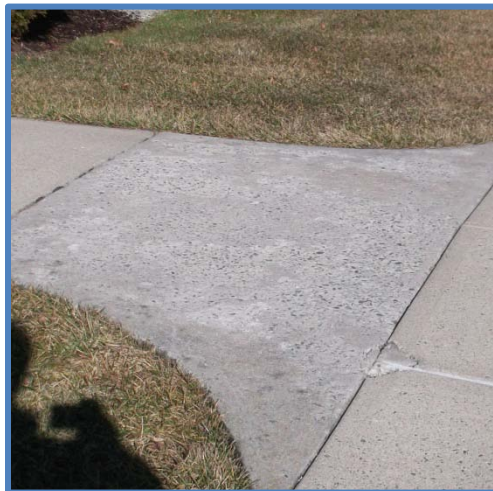
All of the units at the Longview at Montville community contain walks from the driveway to the unit entranceway. The walkways are constructed of Portland Cement concrete or brick pavers. The servicewalks were observed to be in average condition displaying some displaced brick staining and vegetative growth between the bricks.

Scaled Service Walk – Revere Court

Servicewalks that presents a trip or safety hazard should be replaced or “mudjacked” immediately through the operating budget.

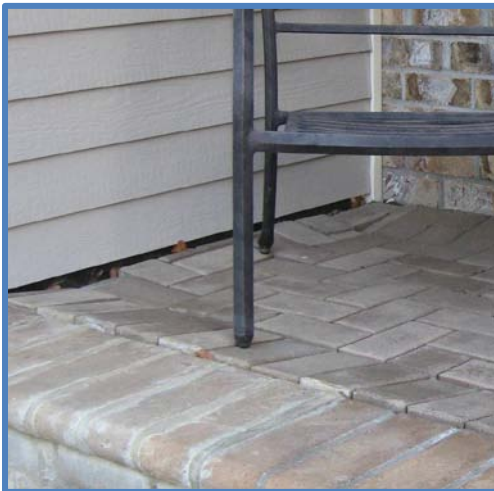
Sunken Pavers at Front Porch

Each unit at the Longview at Montville community is provided with a brick entry stoop to access the front and / or rear door. The entry stoops vary in size and the number of steps and were observed to be in varying condition experiencing some chipping, missing or cracking mortar, settled porch surfaces and staining. The unit cost includes removal and replacement of the brick step treads and landing surface. Replacement of the concrete footings and masonry blockwork is not warranted since it is anticipated that they will perform for the life of the residential structure.

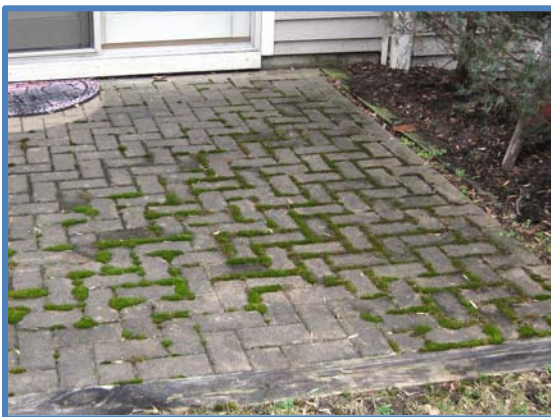
Moss Growth Between Pavers

Each unit at the Longview at Montville community is supplied with a rear and / or front patio that are constructed of Portland Cement concrete or brick pavers. Patios have been observed to be experiencing significant cracking and edge failure throughout. The patios were observed to be in average condition displaying settled pavers, staining and vegetative growth between the concrete paver units.

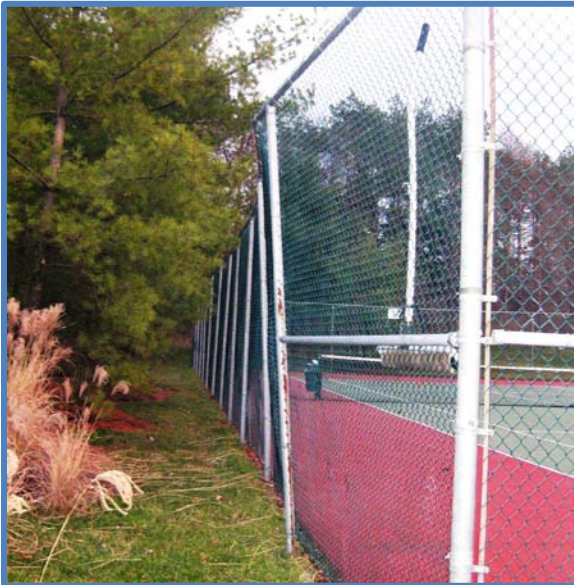
Ten (10') foot high, vinyl coated chainlink fence is located at the tennis courts. Fence of this type has a twenty-five (25) year typical useful life and was observed to be in average condition displaying leaning fence posts, rusted components and warped fence fabric. It is important that the fencing receives regular maintenance in order to ensure it fully achieves its full expected useful life.

Leaning Fence Post

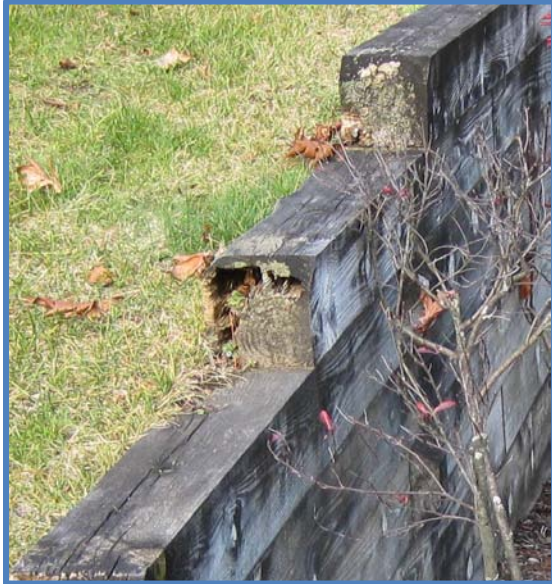
Deteriorated Top Retaining Wall Rail

Wood timber retaining walls are provided throughout the Longville at Montville community. The walls are presently constructed of pressure treated lumber and were observed to be in average condition exhibiting localized deterioration of the top rails and some splitting of the timbers. Wall moisture was evident at many of the walls. The Association intends to keep the retaining walls as timber walls.

Replacement of these walls is anticipated to occur over differing spans of years beginning in 2017. It is recommended that exterior wood products are weatherproofed every three (3) to five (5) years to assure that premature replacement will not be required.

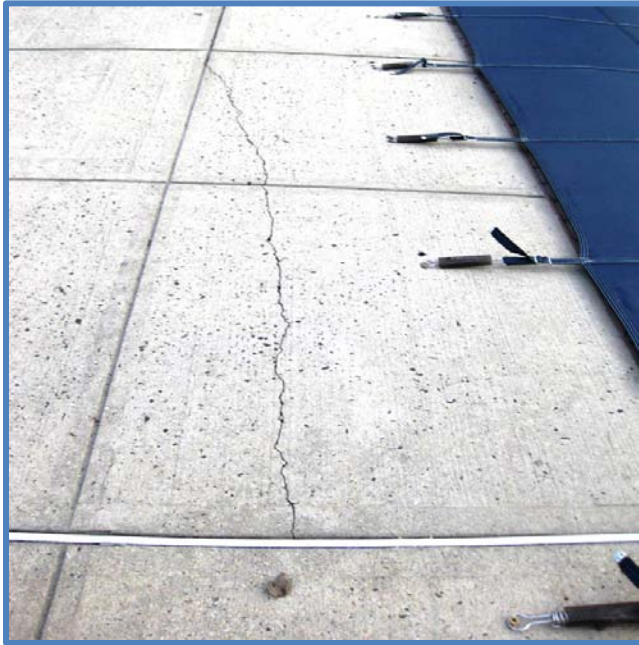
Pool Deck Crack

The deck surrounding the swimming pool is constructed of Portland Cement and decorative brick pavers all which have a thirty (30) year typical useful life. The concrete deck is experiencing cracking. Existing cracks should be monitored for displacement. The paver patio located between the pool deck and the tennis courts was observed to have standing water discoloration and soil debris along the grassed area between the concrete pool deck and the tennis courts. It is suggested that drainage remediation be performed in this area to ensure storm water is properly channeled off of the existing patio surfaces. The concrete patio pavers adjacent to the concrete pool have sunken and must be re-set to avoid trip hazards in this area.

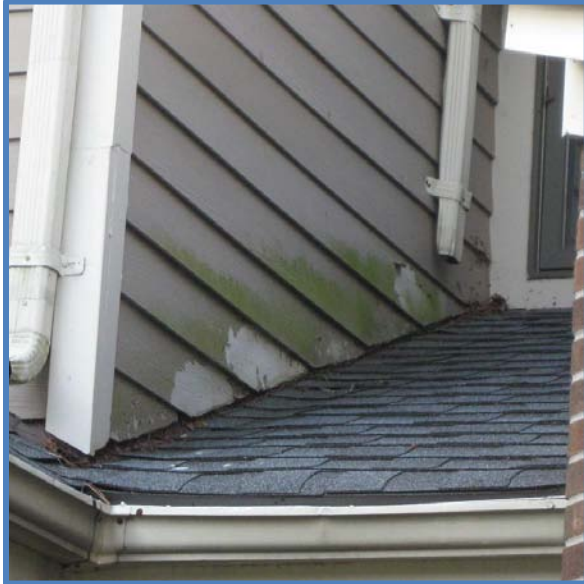
Aluminum gutters and downspouts on the residential and community buildings are in average to below average condition possessing the typical signs of weathering, rusted fasteners, incidental denting, loosening gutter spikes and finish loss. Gutters and downspouts have a typical useful life of twenty (20) years. The Association has deferred the replacement of these systems an additional ten (10) years.

Missing Downspout Accessory

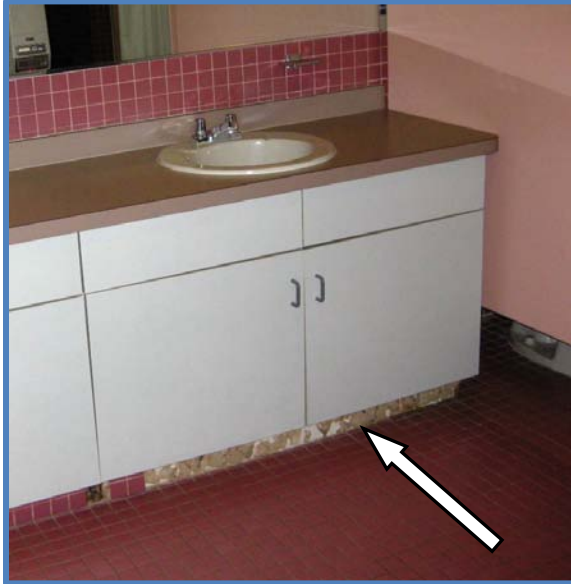
Missing Tile – Women's Room Vanity

Ceramic floor and wall tile is located in the men and women's bathroom facilities as well in the kitchen area. The bathroom tiles were noted to be in average condition displaying stained grout. Tiles were noted to be missing in the vicinity of the vanity kick plate in the women's rest room. Ceramic tile has a typical useful life of thirty (30) years. The replacement cost within the schedule includes removal of the existing tile.
